**REPORT ON A PIECE OF FABRIC ATTRIBUTABLE TO PFALZ D.III 4020/17
AND A PIECE OF PLYWOOD ATTRIBUTABLE TO FOKKER DR.I 425/17
OWNED BY [REDACTED] AND ON LOAN TO
THE GENERAL HAL MOORE MILITARY MUSEUM**

**Charles S. Gosse
August 31, 2018**

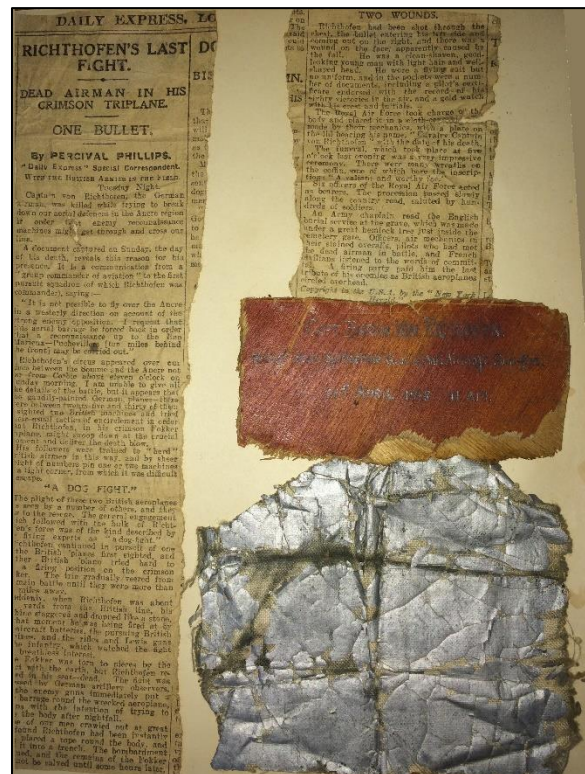
When received by me, these objects were adhered to a piece of paper along with an article titled "Richthofen's Last Flight." by Percival Phillips writing in the London newspaper "Daily Express" and a backing board from the frame which they had been housed in.

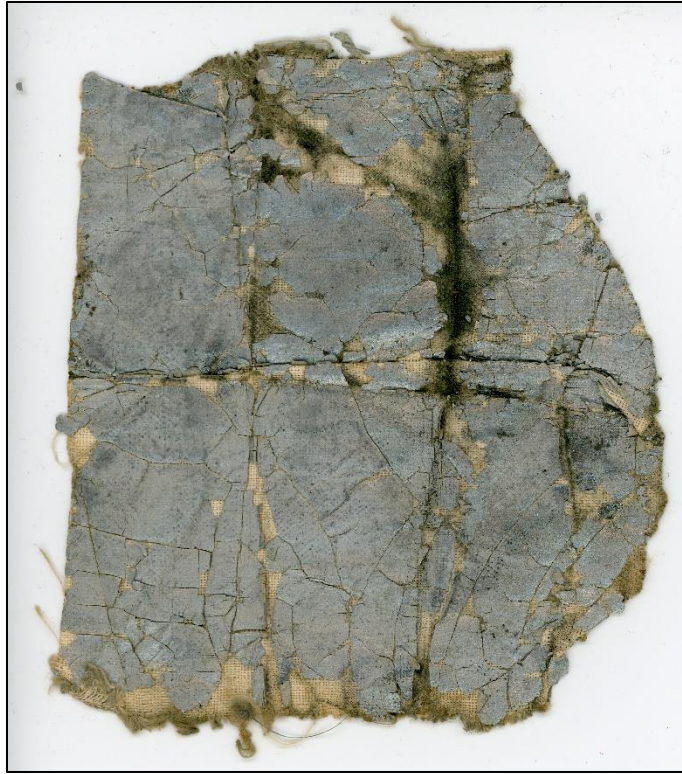
Object No. 1 is a piece of linen fabric made from the fibers of the flax plant. It measures 11.5 cm by 10 cm, one face of which has been covered in a dull, silver-like material. This material has flaked-off in some areas, especially along fold lines.

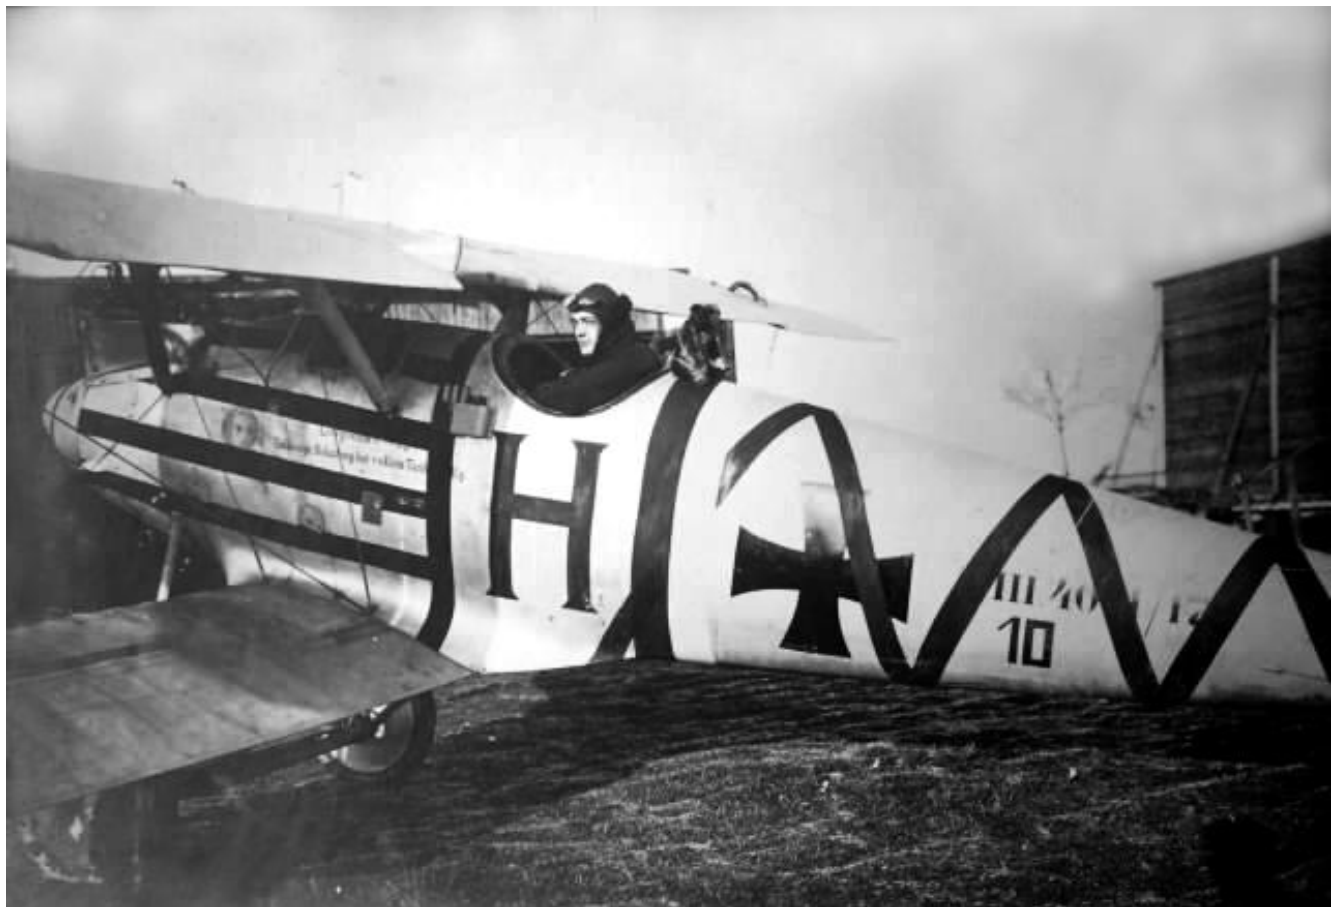
No photos of Pfalz D. 4020/17 with its Jasta or after it crashed on 27 or 28-December-1917 are known to exist. A photo of D.4011/17 of Jasta 21 with it's pilot Fritz Höhn is shown below.

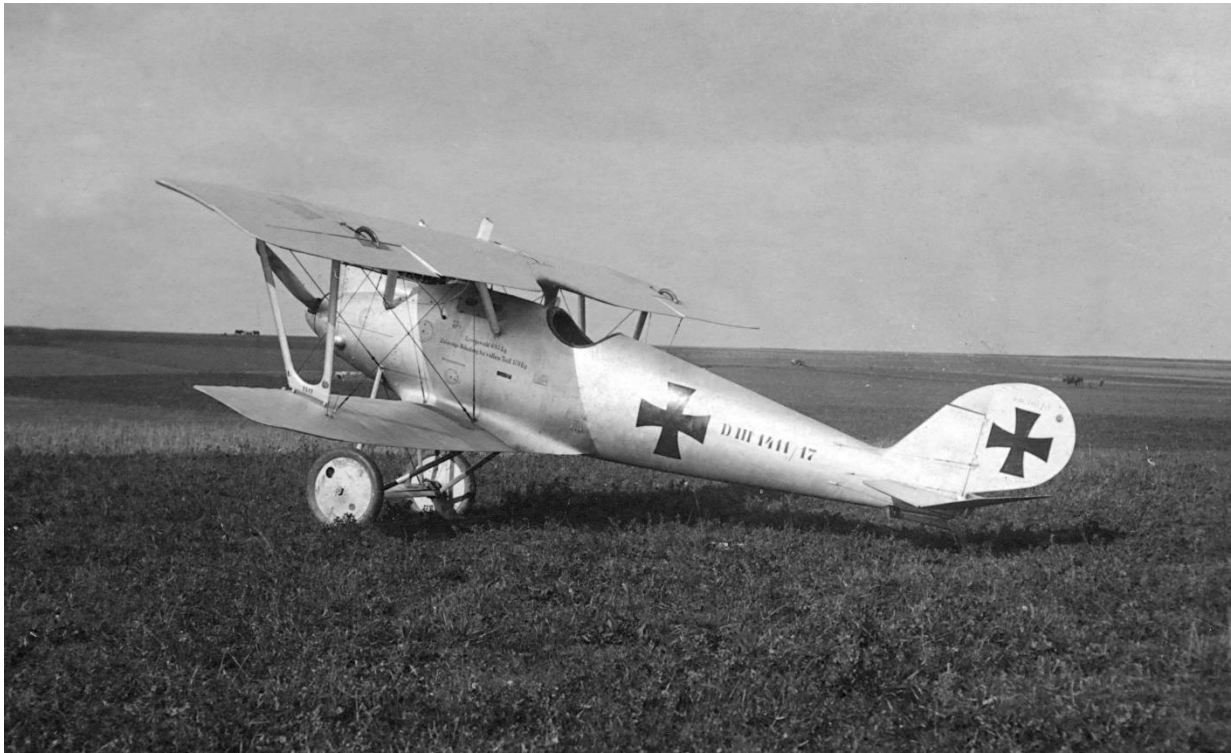
This photo of Pfalz D.III 1411/17 shows the factory-applied silver finish to great affect.

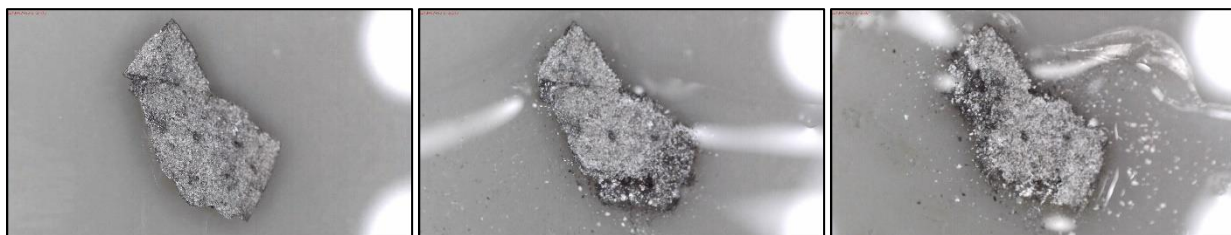
To confirm that the thin silver layer is aluminum-pigmented dope, two tests were performed.⁹ In the first test, acetone was seen to dissolve the cellulose acetate dope and disperse the aluminum pigment. Below are three frames from the film of this test which was made through the microscope as the test occurred. These frames show in progression from the left frame to the right frame the affect of acetone on the silver flake.

The results of these tests lead me to conclude that the silver layer on Object No. 1 is aluminum-pigmented dope; it is not paint. This supports the probability that the sample is from a Pfalz aircraft. Evidence of black pigment was also seen but it is not clear if this black pigment was being used to tint the aluminum.

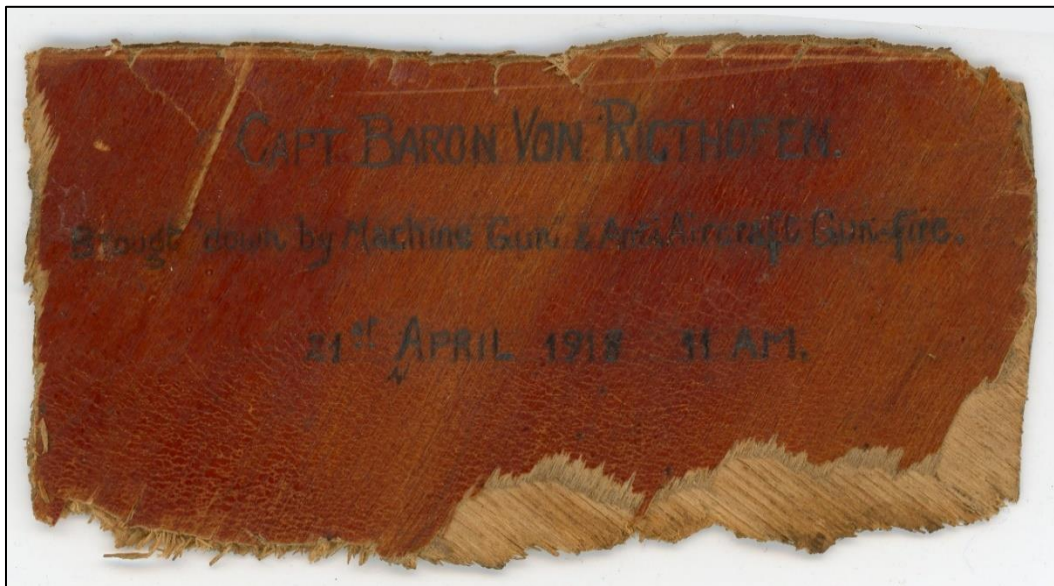
Object No. 2 is the piece of plywood shown below. It measures 10 cm by 5 cm and is 1.3 to 1.73 mm thick and made up of three plies, the middle ply being substantially thicker than the two outer plies that sandwich it. The thin outer plies run in a different direction from the middle ply. One outer ply has a clear coating - possibly dope - that slightly stains it a darker color. The other outer ply does not have a coating or any writing.

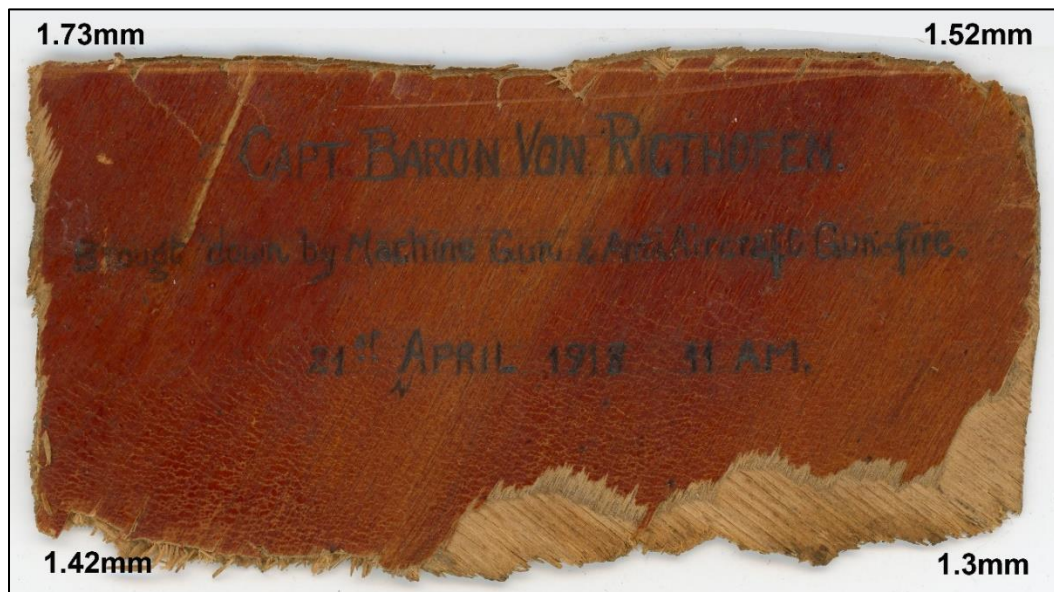
Thickness at various points is shown below. As some of the plywood is missing, it appears that the entire piece may have been at least 1.73 mm thick. The piece is bent or warped in several directions and absent of any moisture. It may be that the thickness of the piece as originally manufactured when it retained moisture and was not yet subject to compression during flight and the aircraft's impact with the earth was greater than 1.73mm.

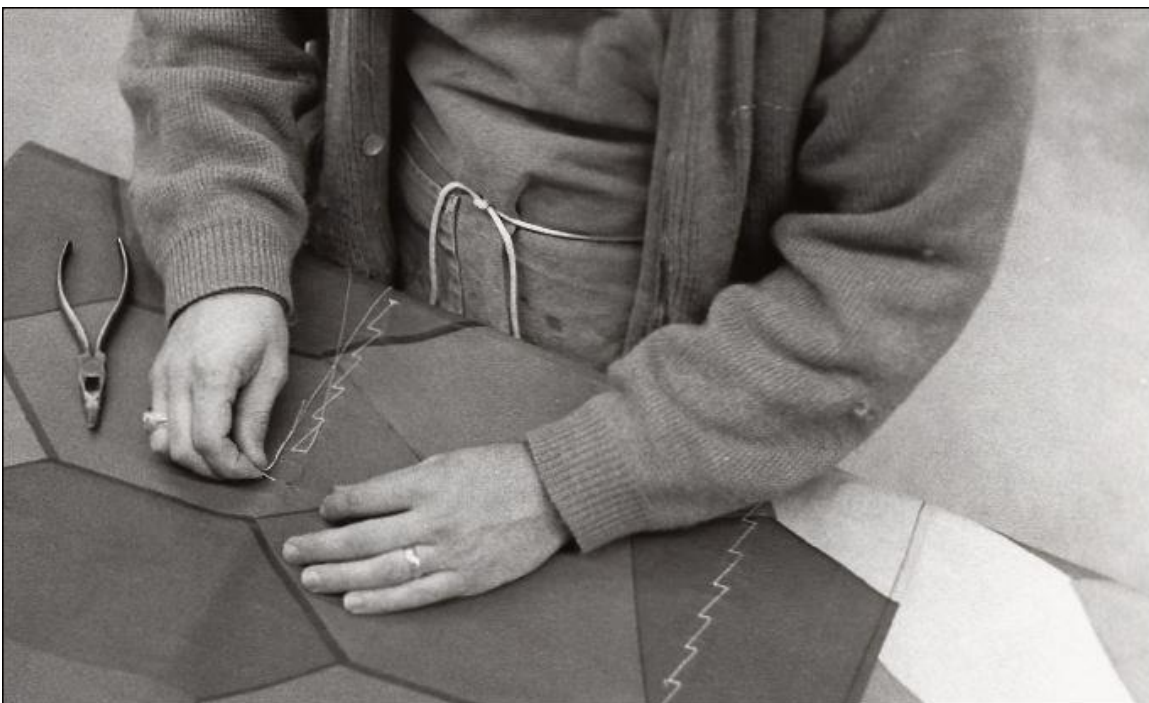
When the wing was finally covered with fabric, a seamstress would stitch the outer fabric covering to the thin fabric running along the cap strip as shown in the photo below of the same Albatros aircraft during restoration.

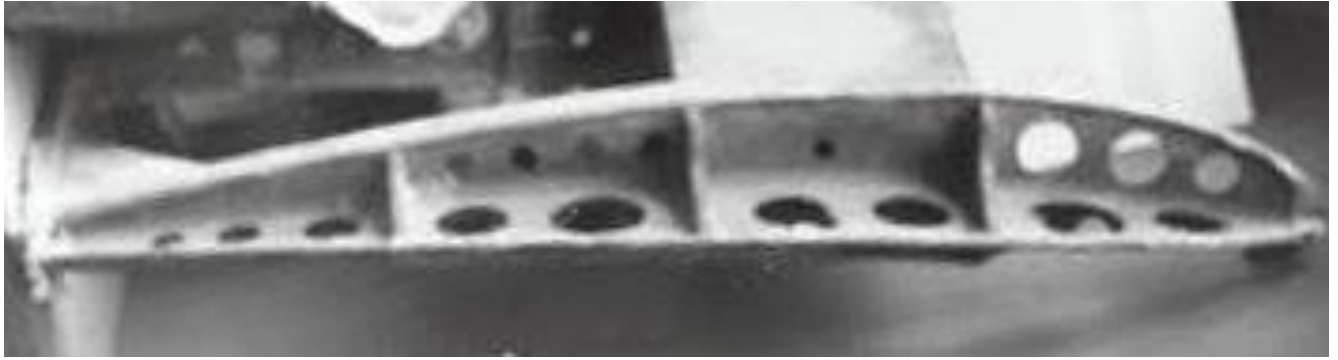
The Fokker triplane had three wings and, therefore, six end ribs from where Object No. 2 could have come from. One of these six is stored at the Royal Canadian Military Institute in Toronto, Ontario, Canada, and shown below.
